Product: Cluster	Description Horn Capacitor Marine Cluster IO and OB	Date Jan 08
Type: Electrical		Issue 1

VDO Marine Customer Service Bulletin

Product Line: All Marine Clusters, I/O and OB **Date:** 6.3.99

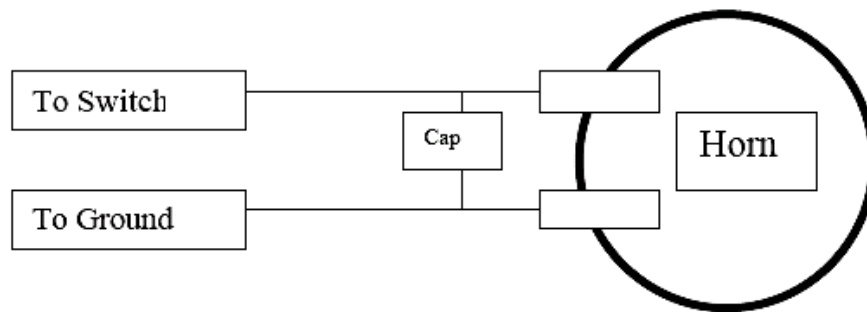
Problem: Using the signal horn will sometimes cause the Cluster to reset (Turn off and then On).

The boat Horn when used will cause a momentary voltage drop that may exceed the cluster 7 volt working threshold causing the cluster to shut off to protect the processor. The cluster will automatically reset when the horn button is released however the depth and clock settings will reset to the default of “No depth alarm” and “12:00”

Field Solution: Installing a 50v, 10 μ f, non polarized Capacitor between the two Horn contacts will eliminate this problem.

The capacitors are available from VDO by calling 1-800-441-1836 or at most electronics stores. (Radio Shack # 272-999)

A permanent corrective action has been taken to see that all future wire harnesses will be built with this unit installed.
