Product: Cluster	Description: Changes to the Bayliner Capri and Bayliner Maxum Wire Harness	Date Jan 08
Type: Electric		1

To eliminate damage to the mode and adjust input circuitry it is necessary to make a simple change to the wire harness.

This change is REQUIRED for all Capri/Maxum boats that use the VDO Instrument Cluster

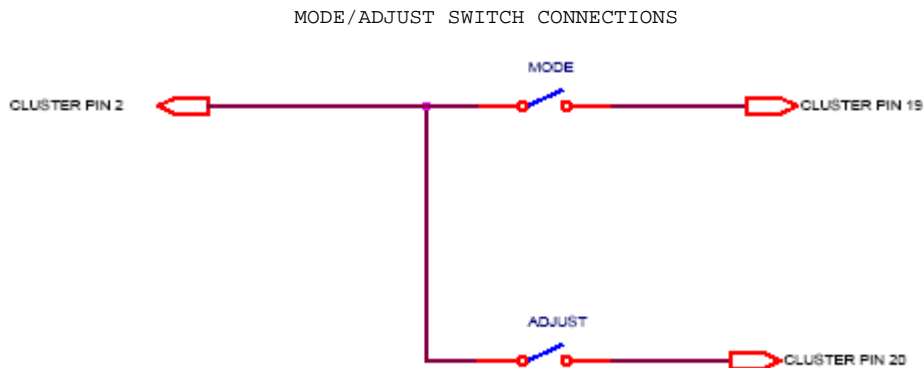
The instrument cluster ground is currently connected via a ground wire with a large ring terminal that is intended to go to the negative terminal of the battery. (See Figure 1) As long as this connection is constantly maintained there is no problem. If this ground connection becomes intermittent, or is not connected, the cluster can seek ground through the mode/adjust switches. This causes the mode/adjust switch isolation diodes to fail due to excessive current if at the time the cluster lighting is turned on.

It is possible due to customer or dealer oversight, that the connection of this ring terminal ground either is not connected or connected to the wrong terminal of the battery.

Figure 1 – Current Location of the “Ring Terminal Ground”

The main instrument cluster ground is pin 4. It is highly recommended that the ring terminal that presently connects directly to the battery negative be replaced with a smaller ring terminal that is compatible with the ground buss bar and re-terminated at the buss bar. This buss bar is located near the battery. (See Figure 2) This will eliminate the problem of not connecting or improperly connecting the instrument cluster ground.

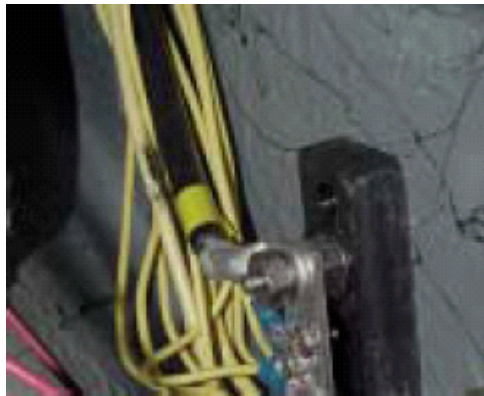
Figure 3 – Current grounding method for the Mode/Adjust switches. Note the Yellow wires labeled 8 and 11. These are the ground wires.

In order to eliminate this problem it must be assured that only one grounding point exists for the cluster under all operating conditions. This can be done by returning the ground for the mode and adjust switches only to the cluster ground at pin 2. The Capri boat that we have used for testing has two grounds connected to the mode/adjust switches. These wires are labeled 8 and 11 (See Figure 3). These ground connections should be disconnected from the switches (taped off and/or clipped) and replaced by a jumper that connects two switches together (where the 8 and 11 ground wires were removed) and then using a single wire connected with a female AMP pin to pin 2 of the instrument cluster. (See Figures 4,5 and 6) Currently there should be no wires connected to this pin. See the schematic below and associated pictures for more detail.
