Product: Cluster	Description: Changes to the Bayliner Capri and Bayliner Maxum Wire Harness	Date Jan 08
Type: Electric		1

To eliminate damage to the mode and adjust input circuitry it is necessary to make a simple change to the wire harness.

This change is REQUIRED for all Capri/Maxum boats that use the VDO Instrument Cluster

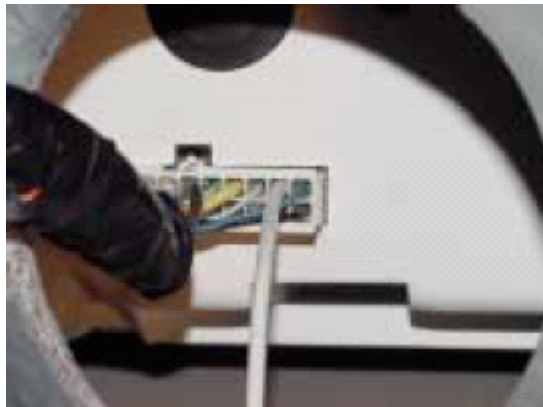
Figure 6 – This is the 24 Pin Connector located on the rear of the Instrument Cluster. The White wire next to the small blue wire is connected to pin 2. This is the new location for the ground wire for the Mode and Adjust Switches.

Note: Disconnect the rear 24 pin connector (as shown in Figure 6) plug from the instrument cluster before making any wiring changes! Reconnect the cluster only after all wiring has been verified to be correct.

In order to eliminate this problem it must be assured that only one grounding point exists for the cluster under all operating conditions. This can be done by returning the ground for the mode and adjust switches only to the cluster ground at pin 2. The Capri boat that we have used for testing has two grounds connected to the mode/adjust switches. These wires are labeled 8 and 11 (See Figure 3). These ground connections should be disconnected from the switches (taped off and/or clipped) and replaced by a jumper that connects two switches together (where the 8 and 11 ground wires were removed) and then using a single wire connected with a female AMP pin to pin 2 of the instrument cluster. (See Figures 4,5 and 6) Currently there should be no wires connected to this pin. See the schematic below and associated pictures for more detail.
